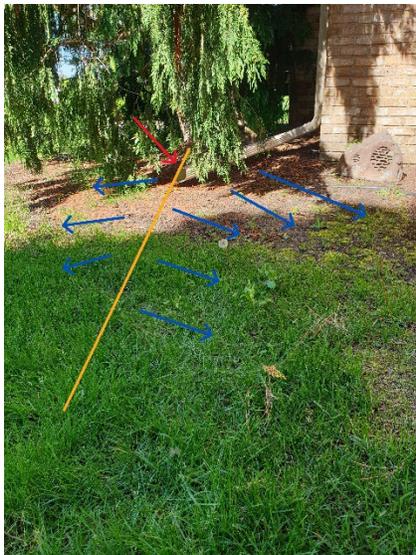
- Noted 5/10/2024:** The gutter extension needs to extend farther from the building. While the distance is well over 3', the slope of the earth is still not shedding the water away from the building. The gutter almost reaches the yellow line where the ground slope changes.

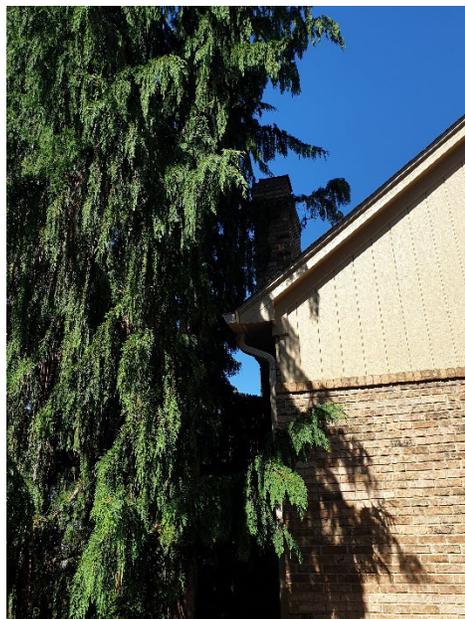
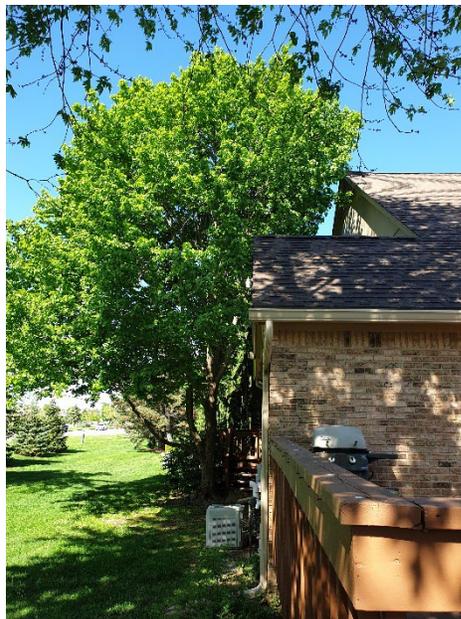
- **NOT ROOF/GUTTER RELATED** Noted 5/10/2024:** There is heavy tree growth along the South side of this building. There are several trees that are in contact with the roof or side of the building that should be trimmed back.

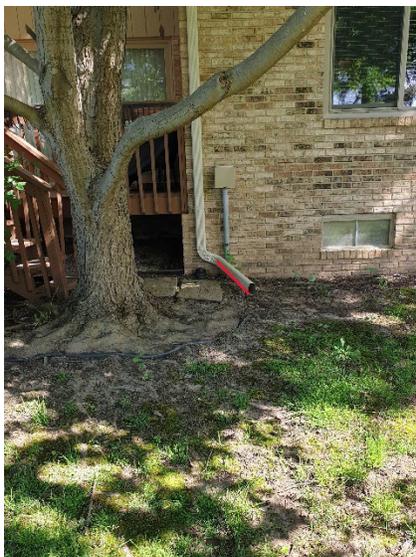
- Noted 5/10/2024:** At the rear, near [REDACTED] the gutter discharge was placed directly in front of the path to leave the rear deck obstructing the path. Additionally, the discharge is directly on top of a tree root system and is washing away the dirt. Downspout should be relocated.

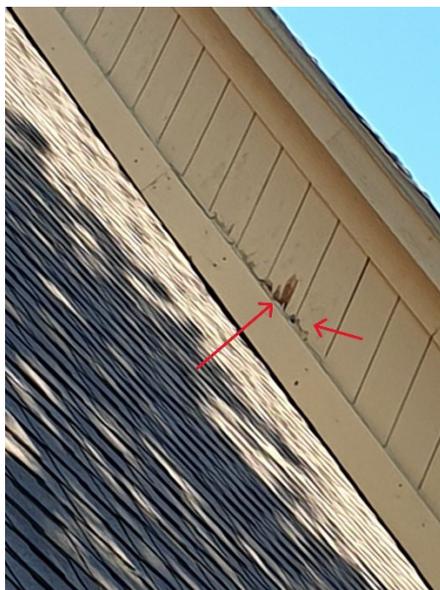
- Noted 5/10/2024:** At the rear of the building in the center, there is chipped T-111 siding from the trim board being removed that should be repainted.

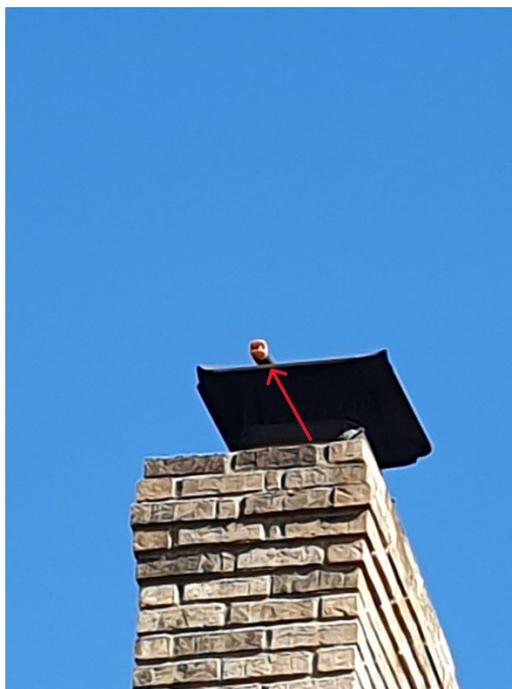
- Noted 5/10/2024** At the east end of the building, there was debris left by the roofer on top of the chimney cap that should be removed.

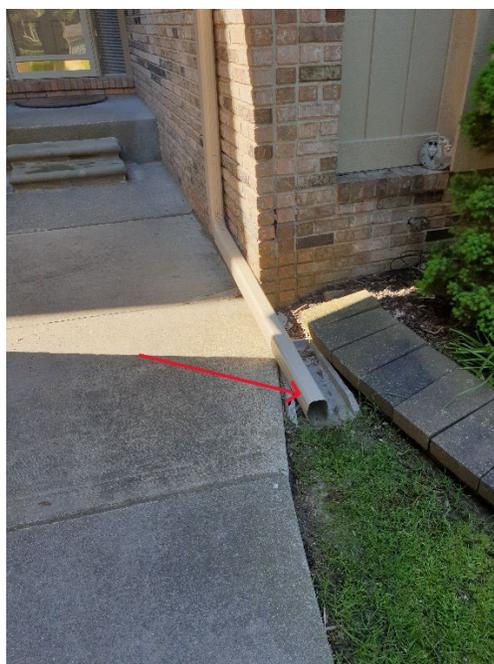
- Noted 5/10/2024:** At the front of [REDACTED] the gutter downspout is discharging at the sidewalk and flowerbed and is too close to both. Discharge will undermine the flower bed and the sidewalk.

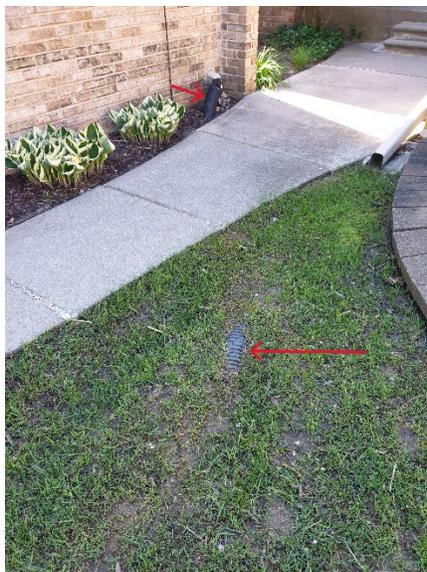
9. **Noted 5/10/2024:** At the front of [REDACTED] One of the downspouts that goes underground has had a portion of the underground pipe rise up above the grass and is not in danger of being crushed or cut by landscapers. This should be re-buried properly.

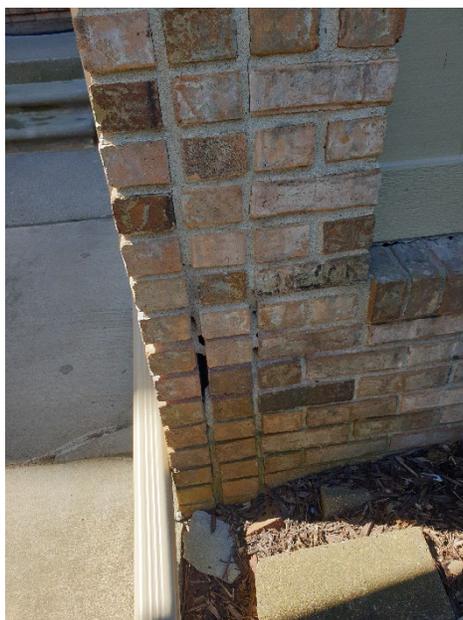
10. ****NOT ROOFING/GUTTER RELATED**** **Noted 5/10/24:** At the entrance to the courtyard at [REDACTED] there is heavy deterioration of the brick mortar. This should be repaired before water can get behind the brick.

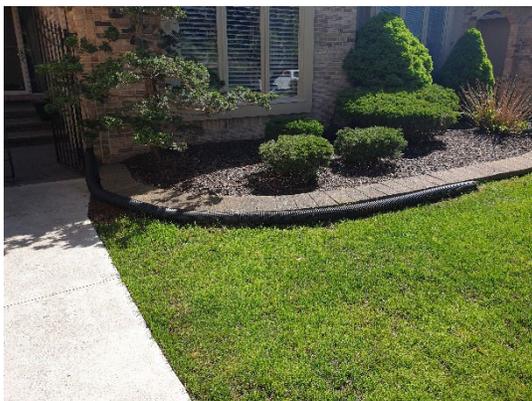
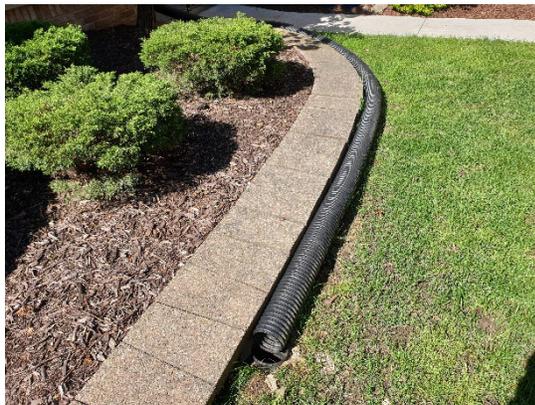
11. **Noted 5/10/2024** In front of [REDACTED] The downspout is connected to an underground pipe just laying on the grass, and not connected to the underground pipe nearby.

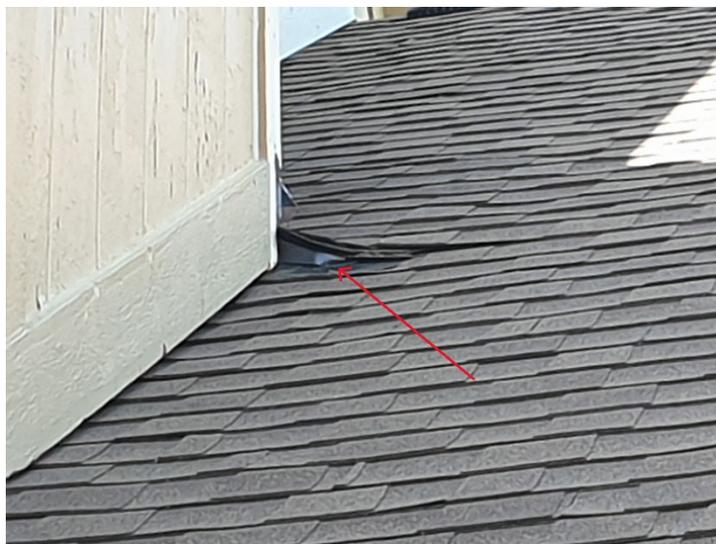
12. **Noted 5/10/2024:** Just inside the courtyard on [REDACTED] there are shingles in the corner over the kitchen that are bucked and cannot seem to lay flat. This should be corrected.

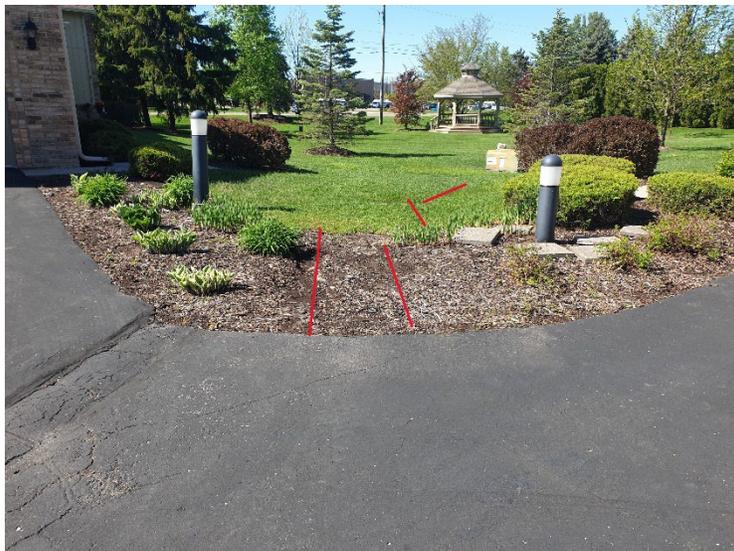
13. **Noted 5/10/2024** Between building 1 and 2 there is still some minor landscaping damage from the trailer/vehicle being moved to the rear yard.

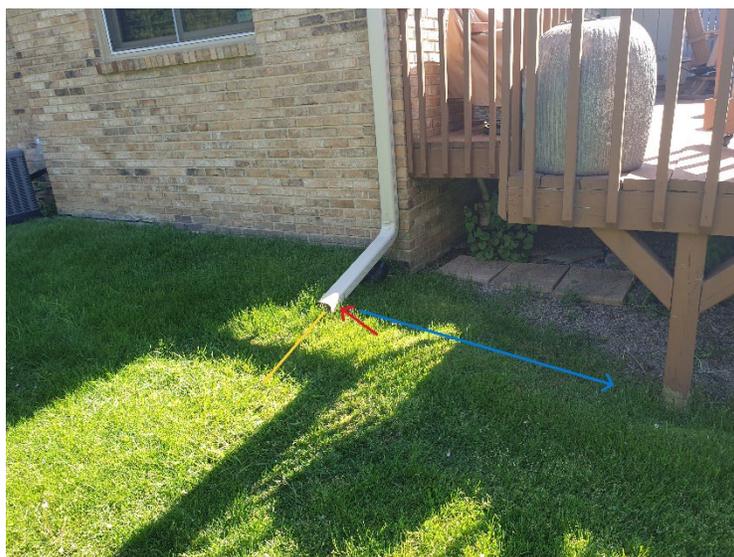
14. **Noted 5/10/2024:** At the rear corner of [REDACTED] the downspout for the gutter needs to be extended away from the base of the deck so as to not wash out the deck foundation. Currently the water is in the direct path of the deck support.

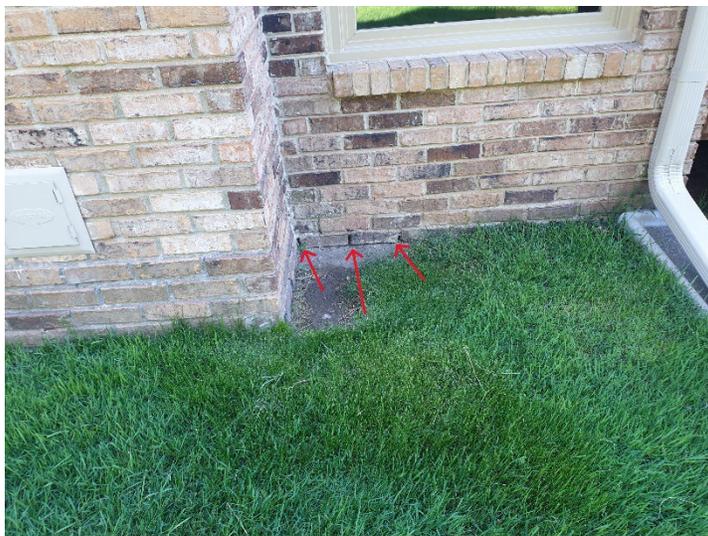
15. ****NOT ROOF/GUTTER RELATED**** Noted 5/10/24: At the rear of [REDACTED] there is some deterioration near the chimney base of the brick mortar. This is significant and given the location should be patched to prevent water intrusion.

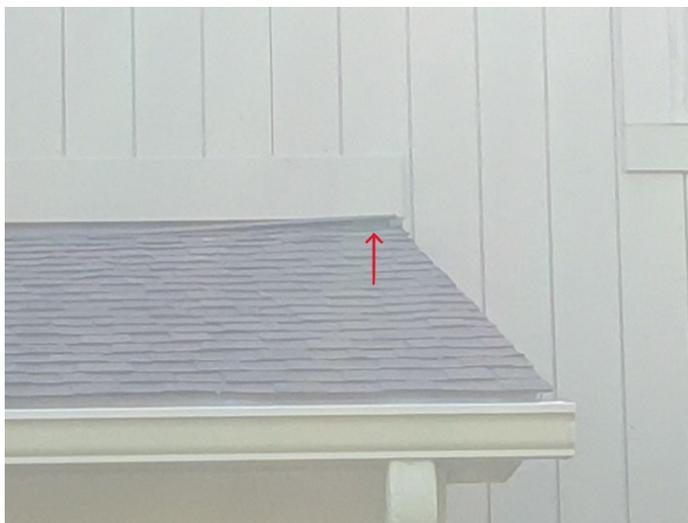
16. Noted 5/10/2024: There is a section in the back of [REDACTED] where there is some debris caught under the edge of the shingles not allowing the shingles to lay flat.

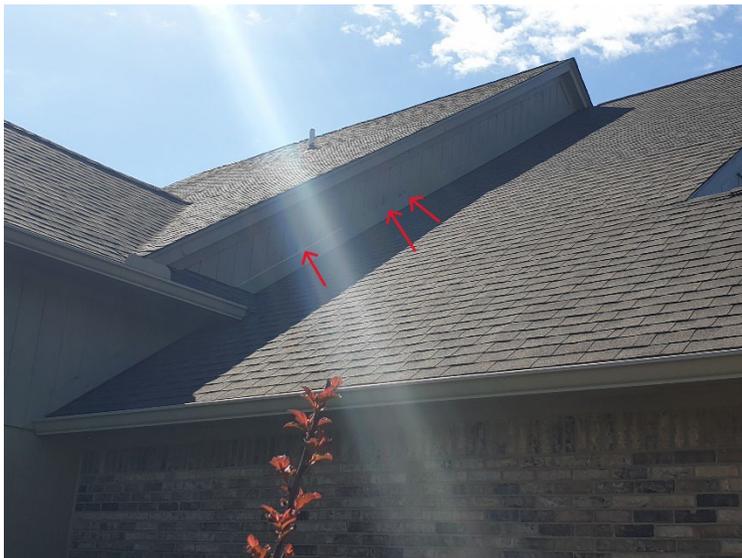
17. **Noted 5/10/2024:** At [REDACTED] there is chipping from removal of the trim boards. These sections need painted.

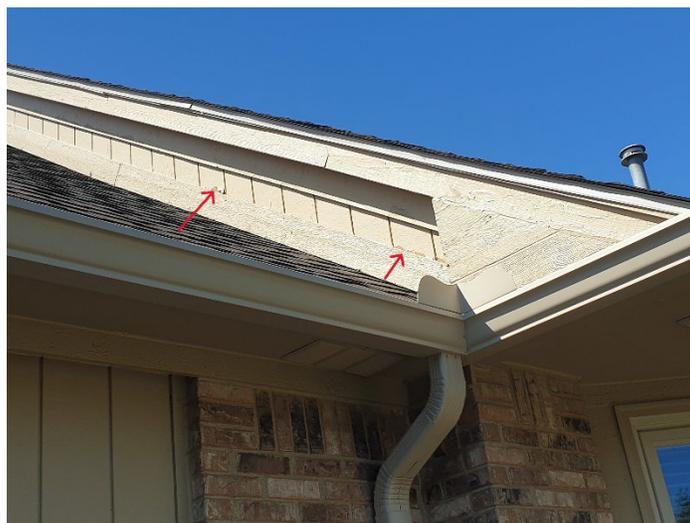
18. **Noted 5/10/2024:** Above the garage at [REDACTED] there is chipping of the siding from trim board removal.

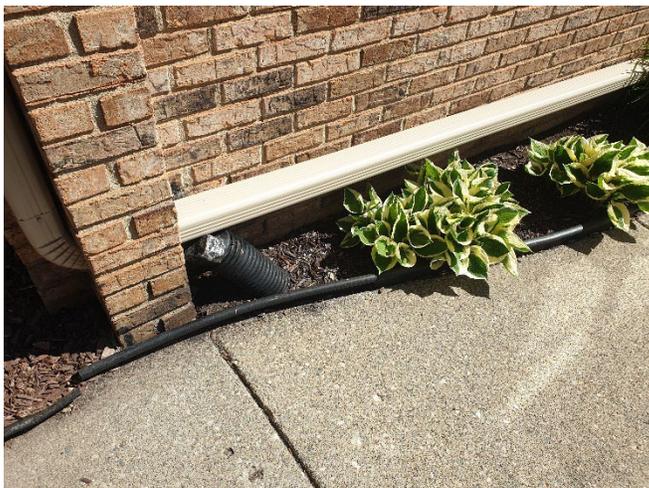
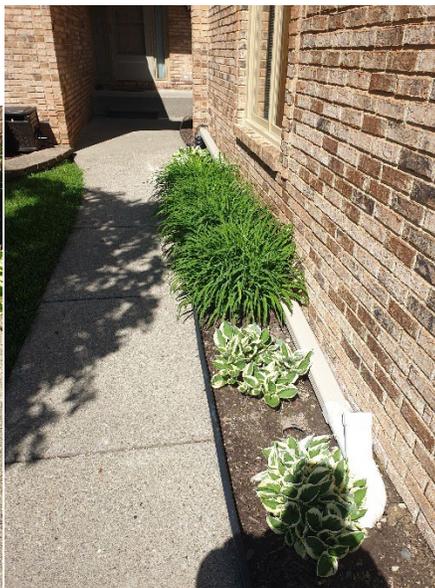
19. **Noted 5/10/2024:** At the front of [REDACTED] there is an old underground downspout left partially above ground and not fully removed. I would question why it was not used and why just left if not being used.

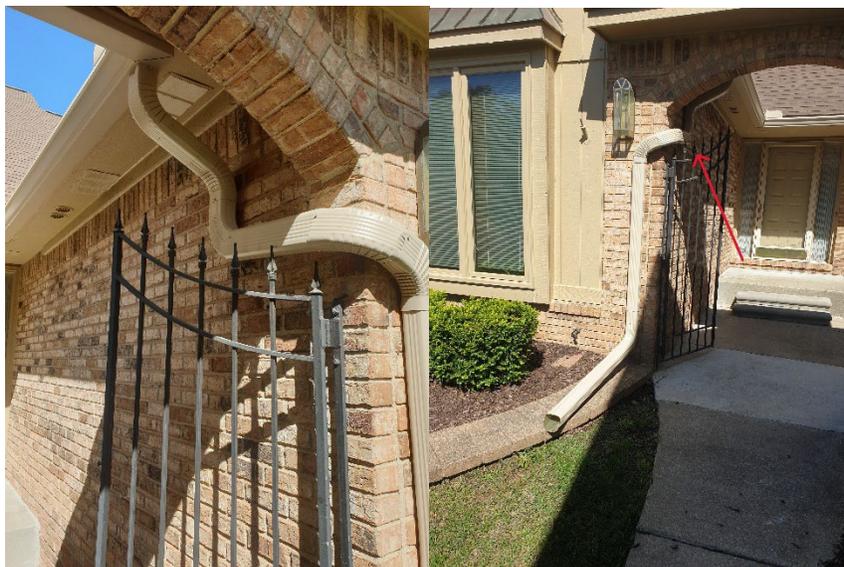
20. **Noted 5/10/2024:** At the front of [REDACTED] the new gutter install is interfering with opening of the iron gate, gutter should be adjusted.

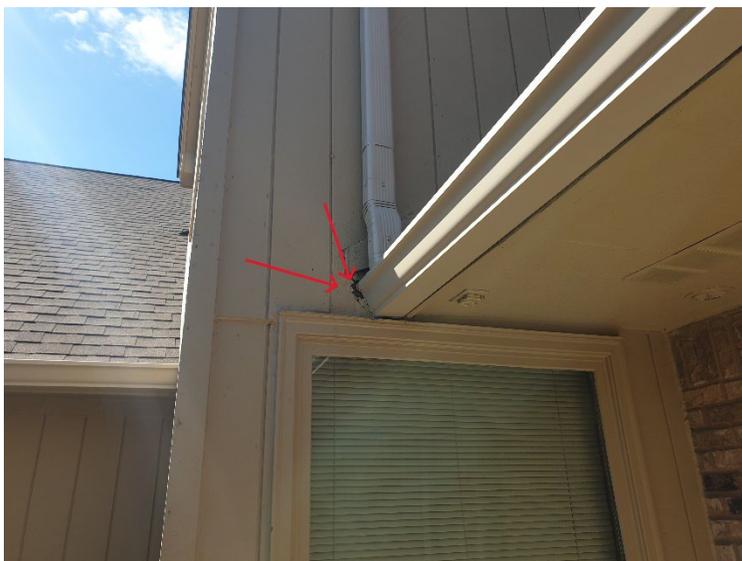
21. ****NOT ROOF/GUTTER RELATED**** Noted 5/10/2024: At the kitchen window on [REDACTED] there is the early stages of rot above the window in the siding. This should be addressed prior to rot extending.

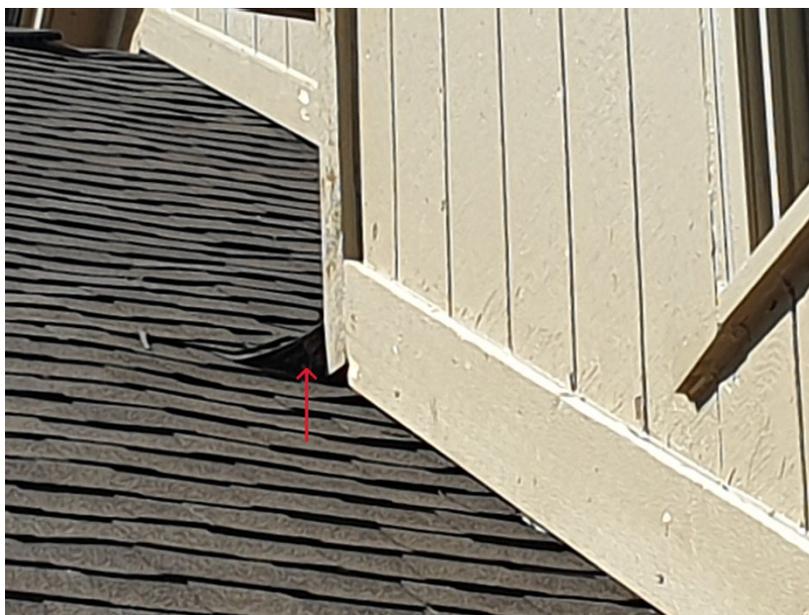
22. Noted 5/10/2024: At the rear of [REDACTED] there is either flashing or debris pushing up the roof tiles and should be flattened.

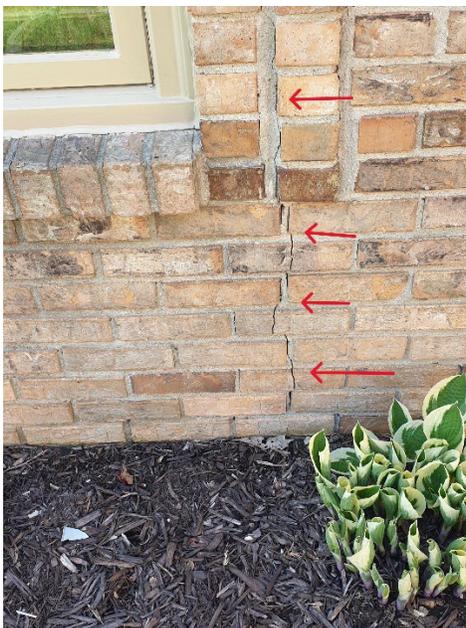
23. **** NOT ROOF/GUTTER RELATED**** Noted 5/10/2024: It was noted there is some significant brick cracking at the front of [REDACTED]. This is not a result of roof work, but should be addressed. Given the size and path of the crack, this could be indicative of foundation settling.

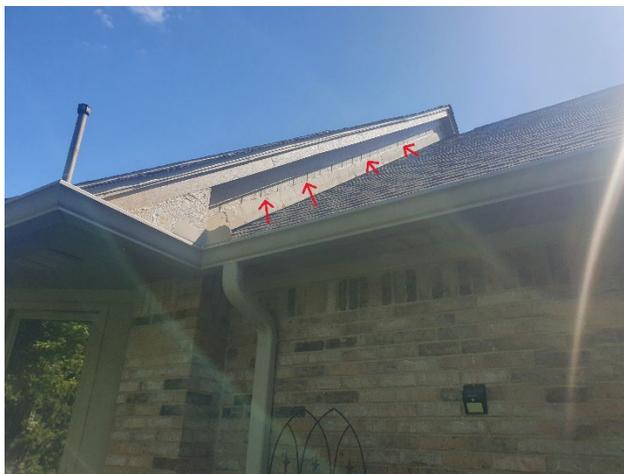
24. Noted 5/10/2024: At [REDACTED] over the garage, there is some chipping of the siding from removal of the trim boards. The exposed wood should be re-painted.

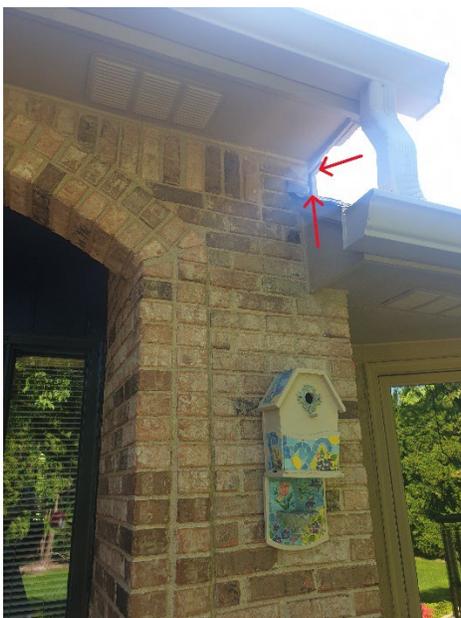
25. **Noted 5/10/2024:** At [REDACTED] above and near the front entry door, there is an end section of trim board that was left unsealed/unpainted. This should be caulked and painted.

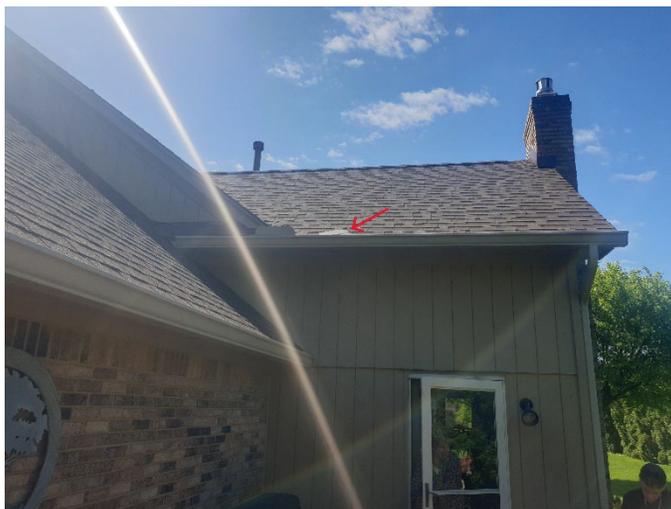
26. **Noted 5/10/2024:** At the rear deck of [REDACTED] there are a couple of loose shingles that have slid down into the gutter. I believe these were just left over shingles, not the result of shingles that came loose after install. I did not see any missing shingles.

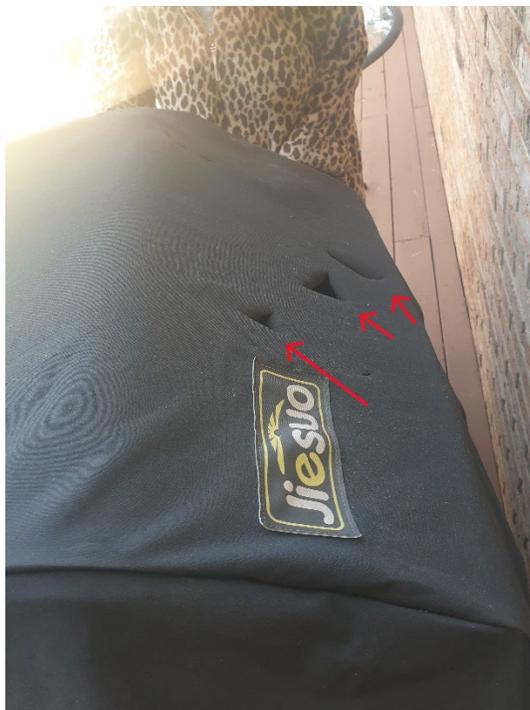
27. **Noted 5/10/2024:** While at [REDACTED] Resident advised that the grill cover was damaged by falling debris from the roof work. She also advised that she knew items were to be removed, but had no way to remove grill. Stated the damage would be noted in the report.

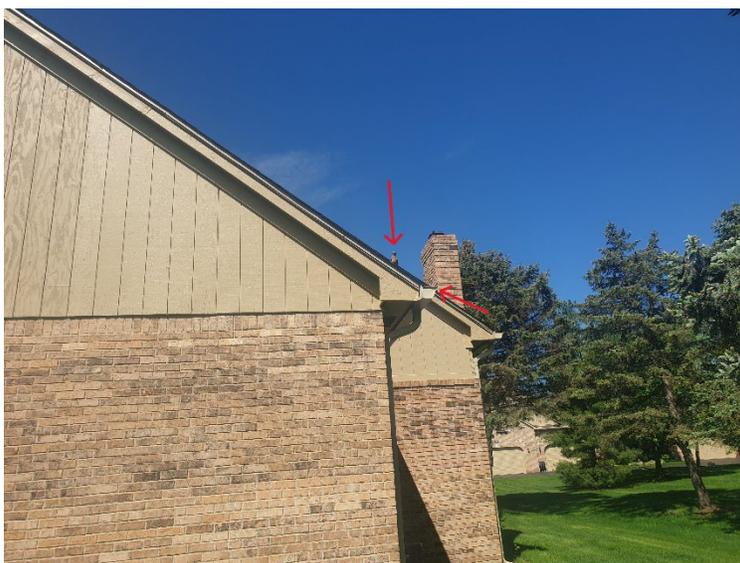
28. ****NOT FAULT OF ROOF/GUTTER INSTALLER**** **Noted 5/10/2024:** At the rear corner of [REDACTED] a Morning Dove has built a nest in the gutter, partially blocking the downspout. Unfortunately I believe there may be eggs in the nest as the bird was very defensive of us getting close to the nest. Recommend contacting a wildlife expert as I do not know the status of this type of bird, or when the nest can be safely removed.

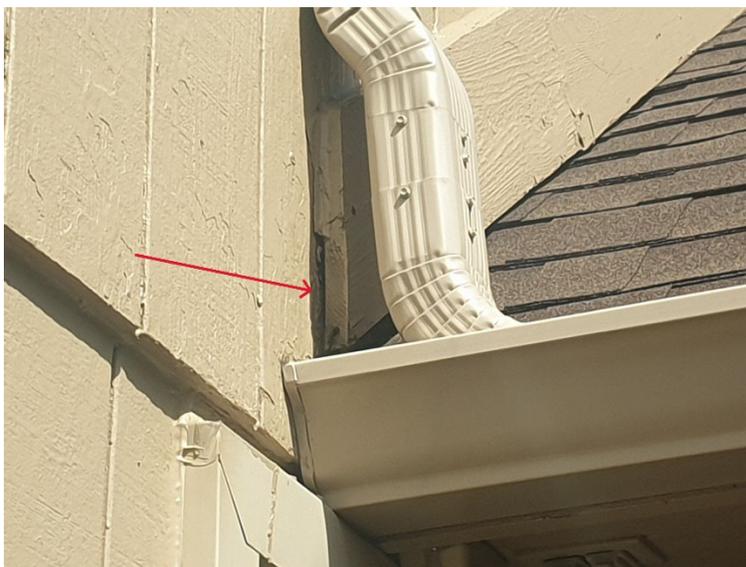
29. Noted 5/10/2024: At [REDACTED] Over the front door there is a piece of trim board that was left uncaulked and unpainted. This piece should be sealed and painted.

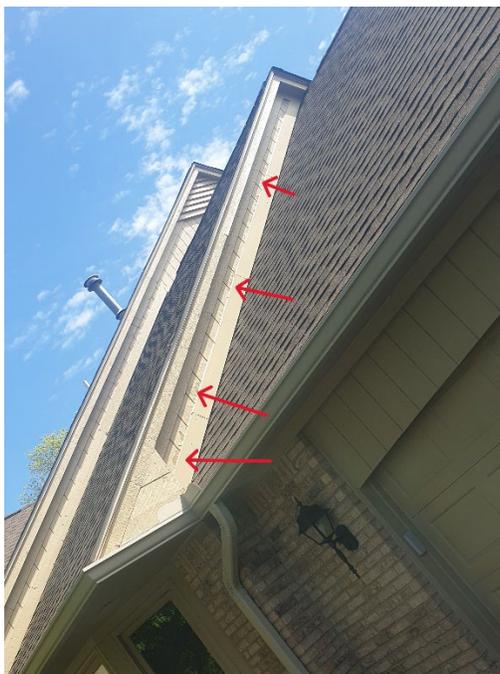
30. Noted 5/10/2024: At [REDACTED] over the garage there is chipping of the siding from removal of the trim boards. Painting should be touched up to protect wood.

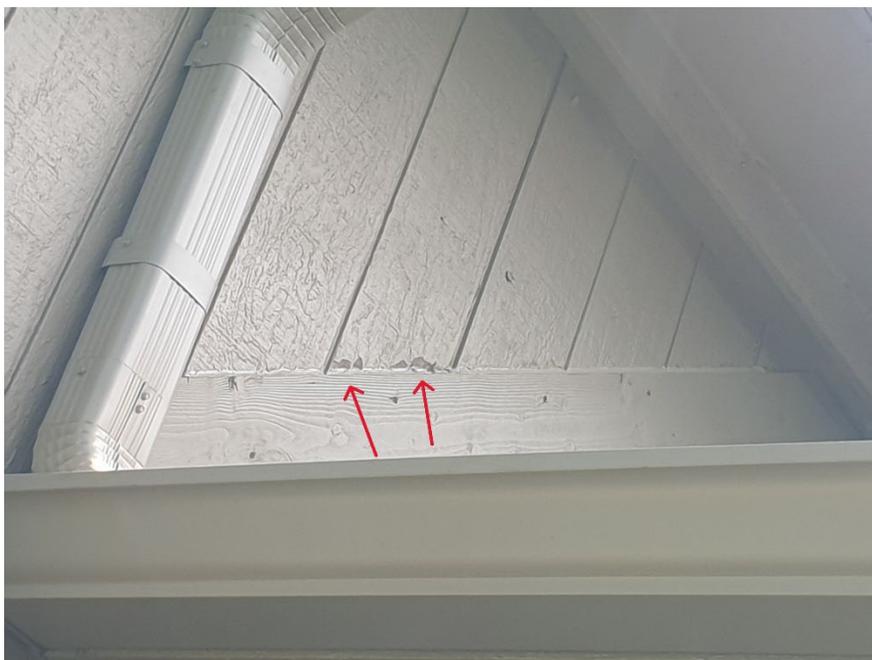
31. **Noted 5/10/2024:** At [REDACTED] over the front door there is chipping to the siding from removal of the trim boards. Paint should be repaired to protect wood.

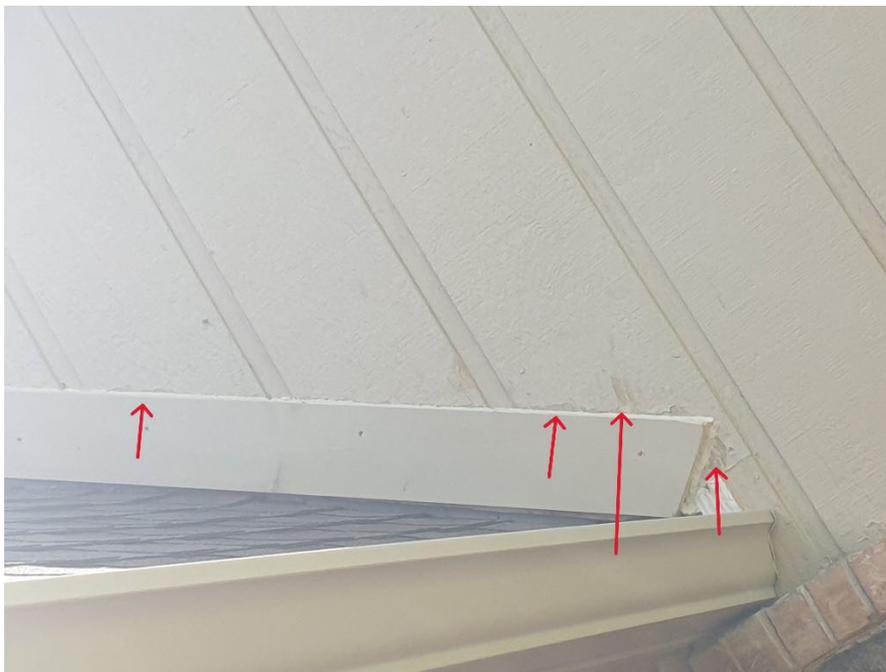
32. **Noted 5/10/2024:** Over the NW corner of the deck there is chipping of the siding that should be repainted to protect the wood.

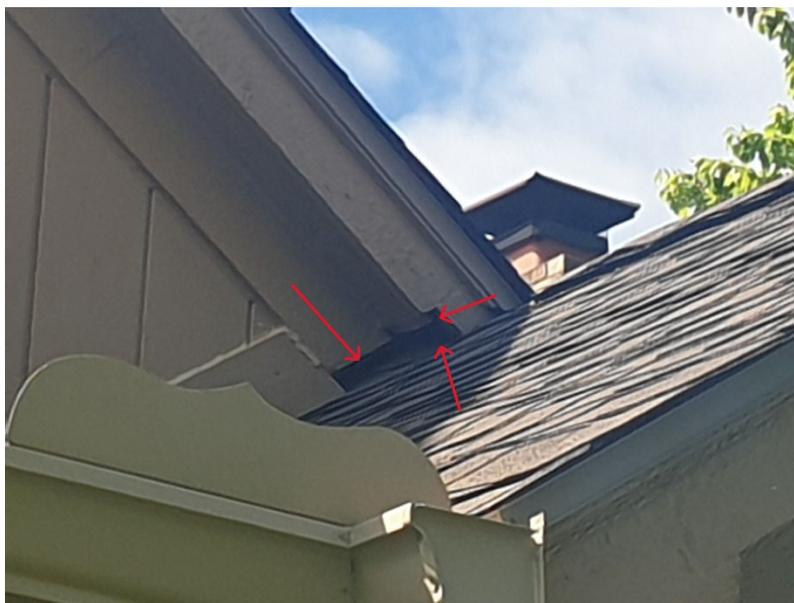
33. **Noted 5/10/2024:** At the junction of roof levels in the back of [REDACTED] there is a section where a gap needs additional flashing and or caulk to be fully sealed for pests/weather.

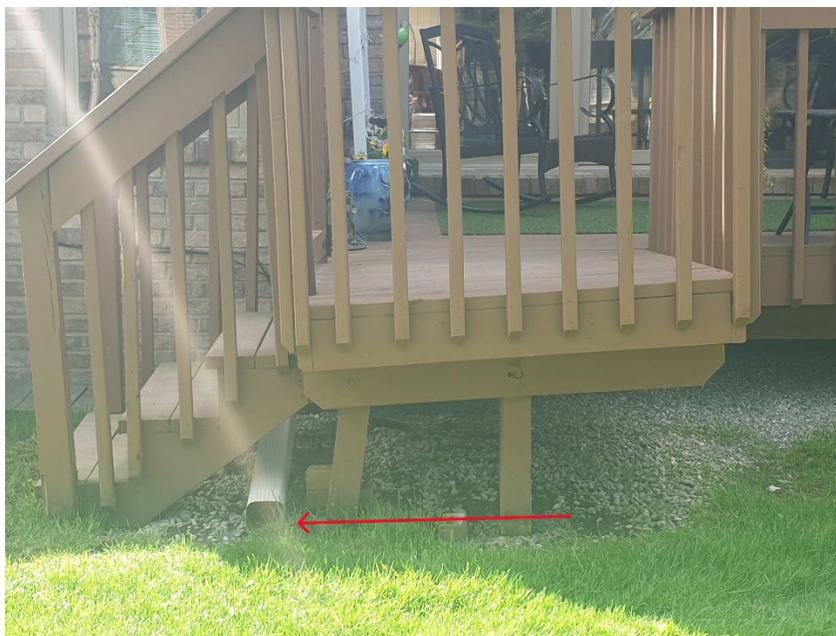
34. **Noted 5/10/2024:** At the rear deck of [REDACTED] the gutter discharge is too close to the deck foundation and should be extended/redirected.

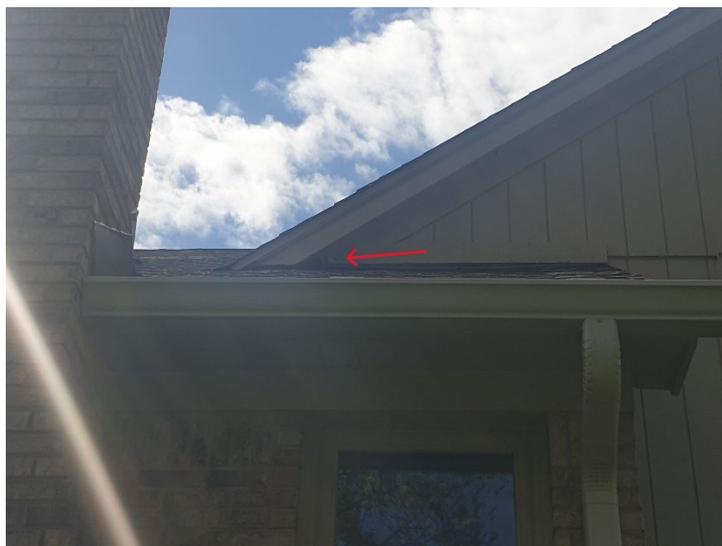
35. **Noted 5/10/2024:** To the right of the chimney at [REDACTED] there is a small section of rotted trim board that should be replaced.

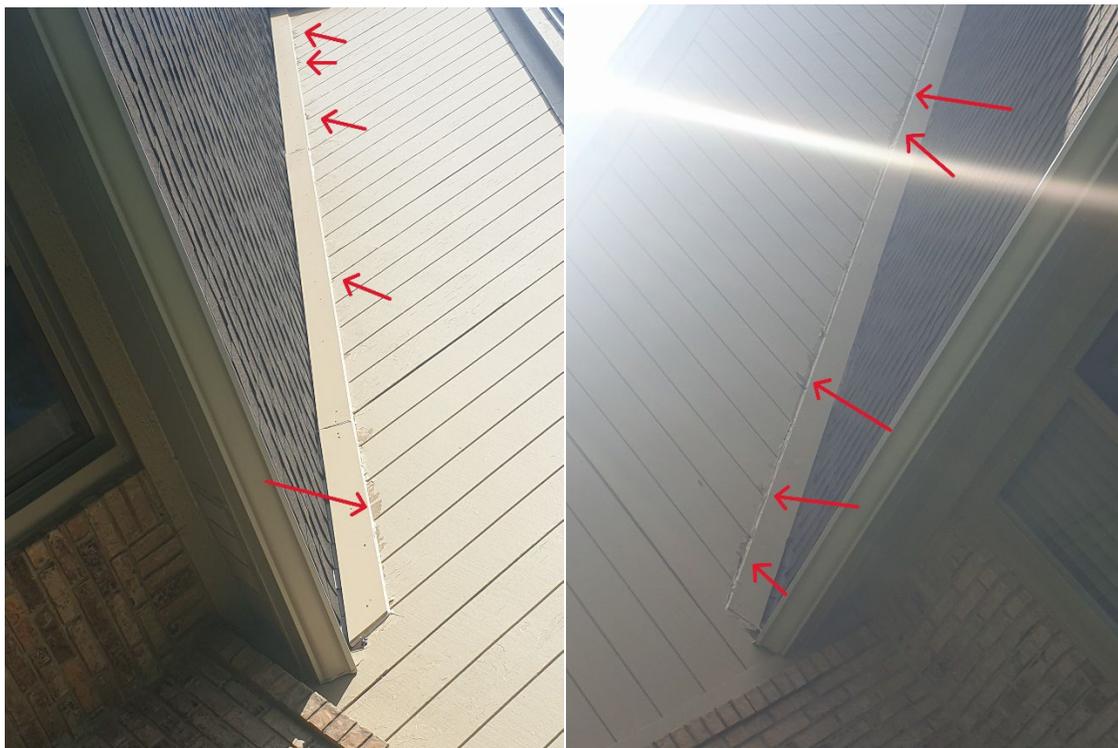
36. **Noted 5/10/2024:** At the rear of the building, near the center there is chipping of the siding on both sides from removal of the trim boards. Paint should be touched up to protect wood.

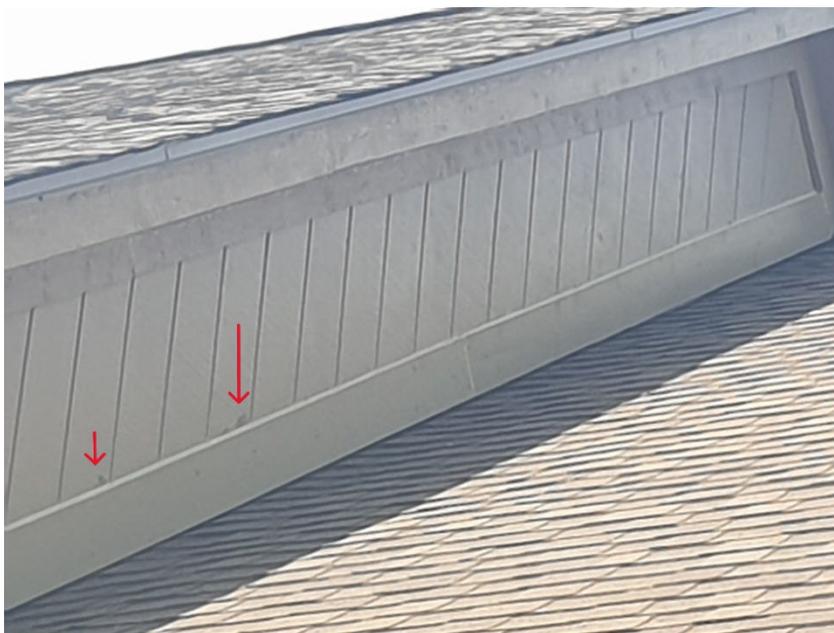
37. **Noted 5/10/2024:** In the front of [REDACTED] there is minor chipping along the siding that should be repaired to protect the wood.

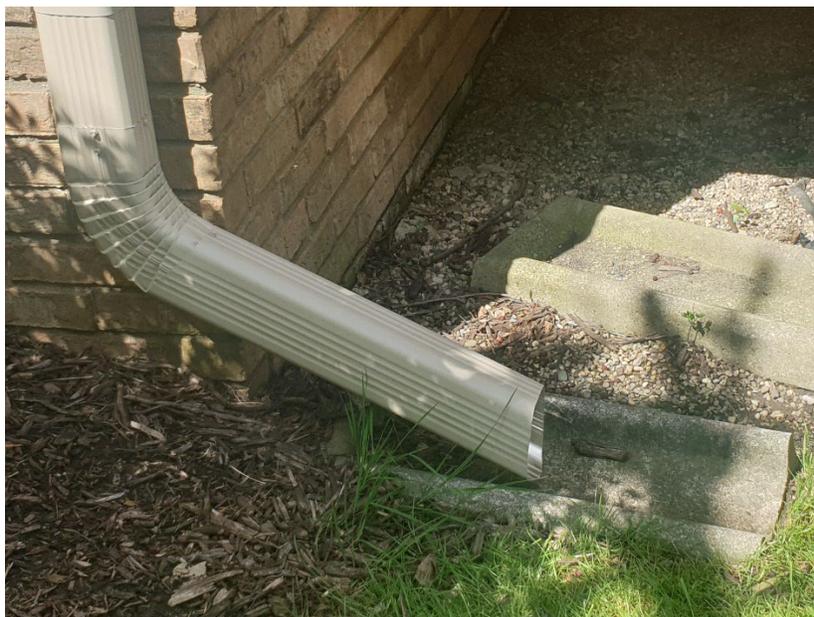
38. **Noted 5/10/2024:** At [REDACTED] the gutter downspout extension was left too short and should extend further from the building.

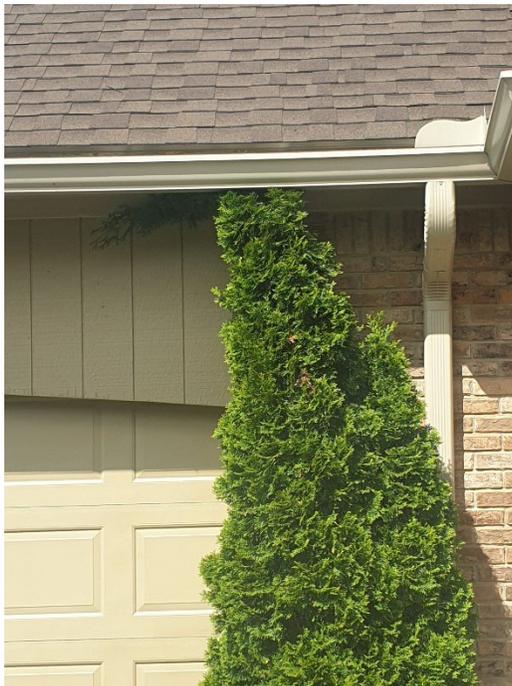
39. ****NOT ROOFING/GUTTER RELATED**** Noted 5/10/2024: At the front of [REDACTED] there is a tree that is pushing against the gutters and needs trimmed.

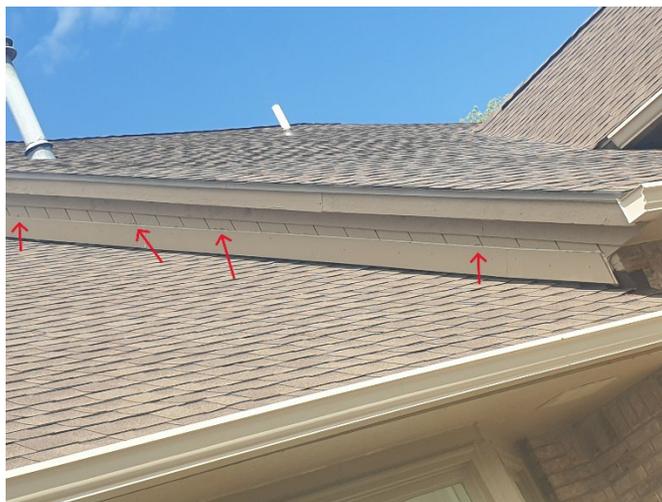
40. Noted 5/10/2024: Near the front door/Garage area the siding has chipped paint from removal of the trim board. Paint should be repaired to protect wood.

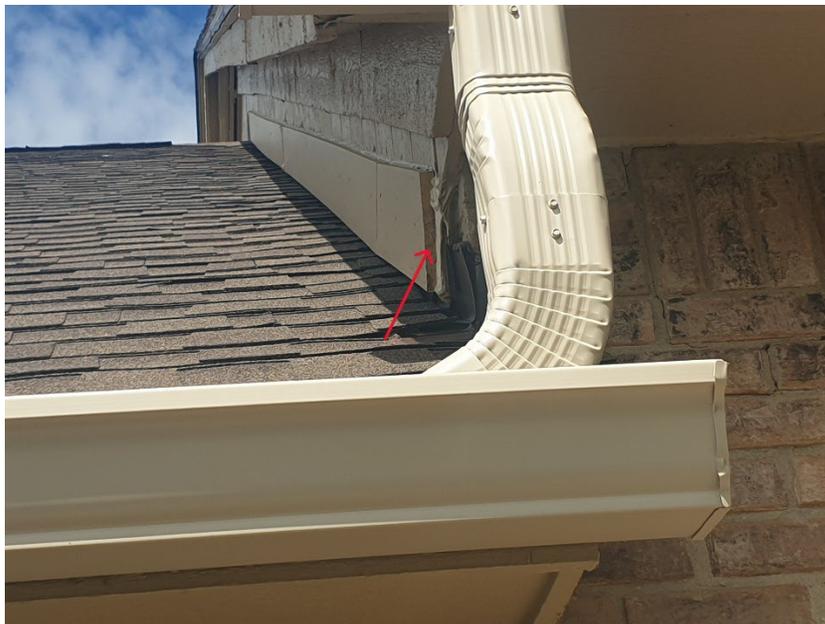
41. **Noted 5/10/2024:** At [REDACTED] over the front door, the end of the trim board was left unsealed and unpainted, this should be completed to protect the wood.

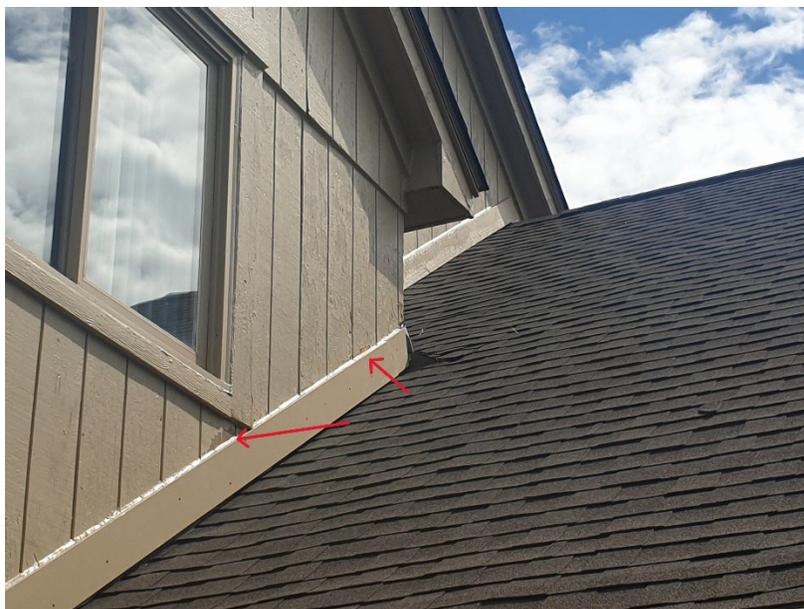
42. **Noted 5/10/2024:** In the courtyard of [REDACTED] there is chipping of the siding from the removal of the trim boards that should be repaired to protect the wood.

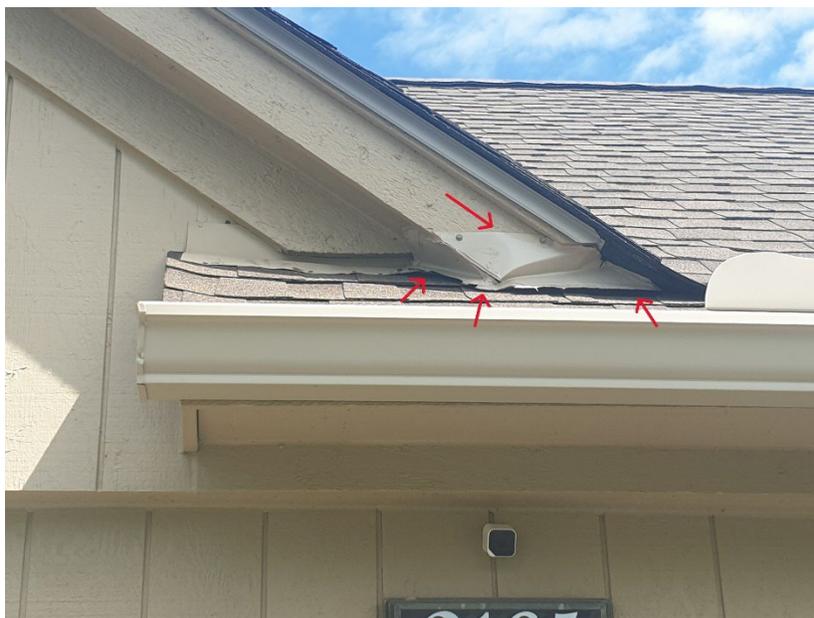
43. Noted 5/10/2024: over the garage of [REDACTED] there is a section of flashing that is not sealed properly and should be corrected.
